Technical Report CERC-96-5
September 1996

Periodic Inspection of Nawiliwili Harbor Breakwater, Kauai, Hawaii

Report 1

Base Conditions

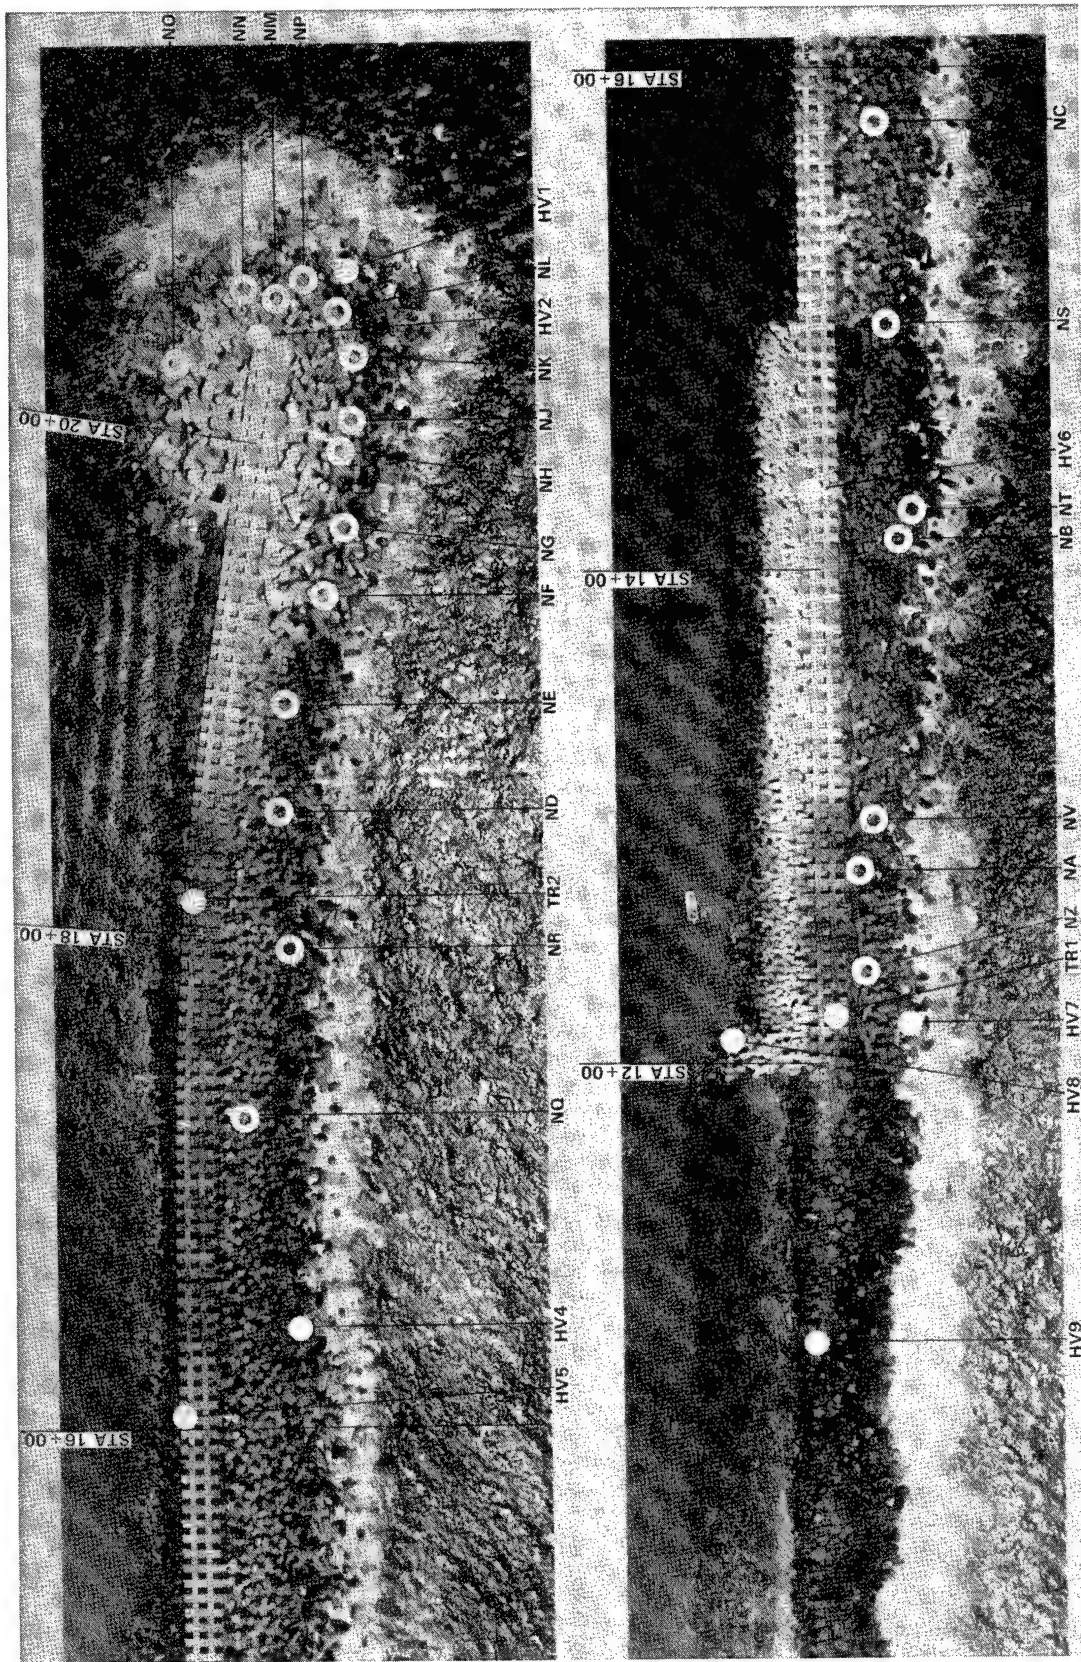
Figure 8. Locations of control points and targeted armor units on Nawiliwili breakwater

In addition, targets were established on selected concrete armor units to serve as a control to check the accuracy of the photogrammetric work. A total of 21 armor units were selected for targeting, 11 along the sea side of the breakwater trunk and 10 around the breakwater head. Along the trunk,

9 of the targeted units were 9,980-kg (11-ton) dolos, and two were 16,150-kg (17.8-ton) tribars. Around the head, 5 units were 20,865-kg (23-ton) dolos, and 5 were 16,150-kg (17.8-ton) tribars. Selected units were distributed along the outer 260-m (850-ft) length of the breakwater and from the crest to the waterline. Dolosse and tribars were chosen roughly in proportion to the relative frequency of each unit along a particular length of breakwater. Units were chosen for targeting that had flat surfaces close to horizontal to maximize their visibility in aerial photography and allow for accurate representation of armor unit movement. Figure 8 shows the locations of targeted armor units on the Nawiliwili Harbor breakwater using an identifier of NA, NB, etc.
